DEPARTMENT OF TRANSPORTATION

Quality Assurance and Source Inspection

Contract #: 04-0120F4Cty: SF/ALA Rte: 80 PM: 13.2/13.9File #: 69.28**WELDING INSPECTION REPORT****Resident Engineer:**Pursell, Gary**Address:** 333 Burma Road**City:** Oakland, CA 94607**Report No:** WIR-014277**Date Inspected:** 06-May-2010**Project Name:** SAS Superstructure**OSM Arrival Time:** 700**Prime Contractor:** American Bridge/Fluor Enterprises, a JV**OSM Departure Time:** 1900**Contractor:** Zhenhua Port Machinery Company, Ltd (ZPMC), Changxing Island **Location:** Shanghai, China**CWI Name:** Wu Chi Cheng**CWI Present:** Yes No**Inspected CWI report:** Yes No N/A**Rod Oven in Use:** Yes No N/A**Electrode to specification:** Yes No N/A**Weld Procedures Followed:** Yes No N/A**Qualified Welders:** Yes No N/A**Verified Joint Fit-up:** Yes No N/A**Approved Drawings:** Yes No N/A**Approved WPS:** Yes No N/A**Delayed / Cancelled:** Yes No N/A**Bridge No:** 34-0006**Component:** Orthotropic Box Girder(OBG)**Summary of Items Observed:**

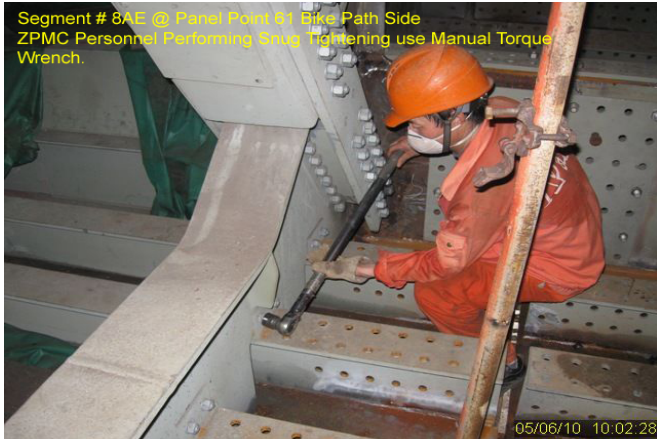
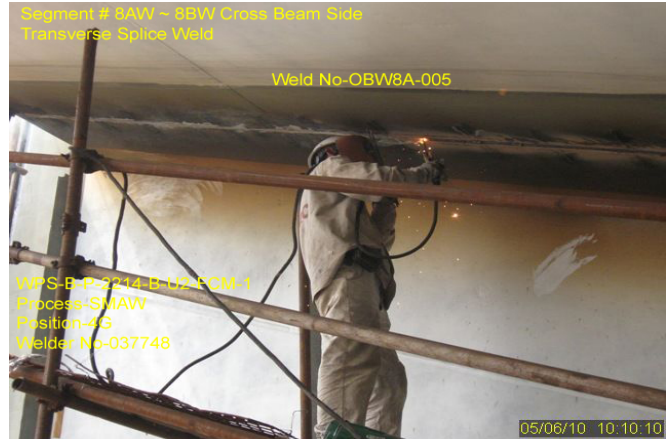
This Quality Assurance (QA) Inspector witnessed final tension verification for Catwalk at Bottom Panel from Panel Point (PP) 61 ~ PP 71 for Segment 8AE ~ 8CE. Inspected 10% on a random basis and found the tension to be in general compliance. Inspection was performed against the Notification No. 00341 Dated May 6, 2010.

Bolt sizes used were M16 x 45 RC Set# DHGM160001 and final torque required was 210 N-m.

Bolt sizes used were M16 x 50 RC Set# DHGM160004 and final torque required was 180 N-m and

Bolt sizes used were M16 x 65 RC Set# DHGM160006 and final torque required was 180 N-m.

Manual Torque wrench was been used with Sr. No. XQ2-114. Please refer the pictures for more comprehensive

This QA inspector observed ZPMC qualified welding personnel identified as 037748 perform Shielded Metal Arc Welding (SMAW), weld joint identified as OBW8B-005; ZPMC QC is identified as Mr.Zhang Hai Tao. The welding parameters measured using QC's calibrated instrument appeared to be in general compliance with WPS-B-P-2214-B-U2-FCM-1. See the attached below Photo.

This QA inspector observed, Heat Straightening Perform ZPM QC is identified as Mr.Wang Jie. The max Deformation is about 6mm Heat Straightening the width is 50 ~100mm. The variables recorded by QC appeared to comply with the Heat Straightening Report (HSR) was HSR1 (B) -8256 Rev-0 dated 2010-04-04. See the attached below Photo.
